三峡库区典型顺斜向岩质滑坡变形破坏特征及失稳机制分析

Deformation characteristics and failure mechanism of large-scale obliquely dip rock landslide in the Three Gorges Reservoir Region

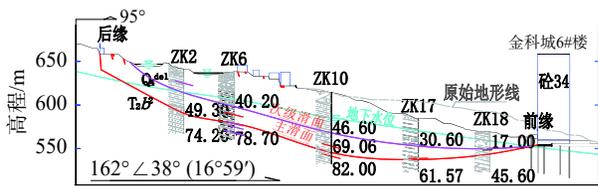
图 2 白杨湾滑坡典型剖面图
Fig. 2 Typical profile of Baiyangwan landslide

滑体主要由第四系人工填土 (Q_4^m) 和第四系坡积层 (Q_4^{del}) 组成,厚度约 20.7 ~ 59.0 m。滑体材料在垂向上的异质性很强,上部为含砾粉质黏土,下部为风化的层状泥岩和砂岩 (图 2)。

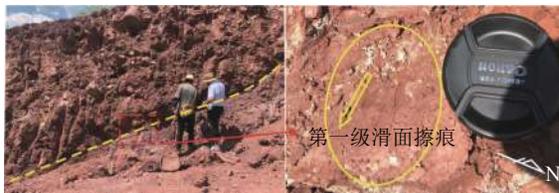
图 3 开挖区裸露的第一级滑面
Fig. 3 First order slip zone exposed in excavated area

白杨湾滑坡有两级滑带。第一级滑带位于滑体泥岩破碎岩体内,滑带土由粉质黏土组成,埋深 18.25 ~ 26.20 m,可见明显的镜面和擦痕 (图 3),滑带厚度 0.20 ~

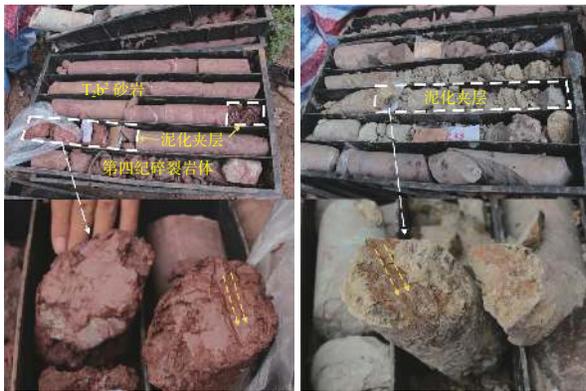
图 4 钻孔揭示滑带
Fig. 4 Drilling to reveal sliding zone

0.50 m, 经 XRD 测试可知, SiO_2 含量 50% ~ 60%, Al_2O_3 含量 18% ~ 19%, Fe_2O_3 含量 6.5% ~ 7.5%, MgO 含量 3.5% ~ 5.5%, K_2O 含量 2.5% ~ 4%, $\text{Si} : \text{Al} : \text{Fe} : \text{Mg} : \text{K}$ 为 10 : 6 : 2 : 1 : 1, Si 占绝对优势, 其矿物组成主要是石英、伊利石、铁、绿泥石、蒙脱石。第二级滑带主要位于破碎岩体 Q_4^{del} 与 T_2b^2 基岩接触面, 埋深 36.60 ~ 56.00 m, 滑带物质为紫红色黏土, 滑带厚度约 0.50 m, 钻探揭示滑带擦痕、镜面清晰可见(图 4)。

(a) 钻孔揭露层滑带, 为紫红色泥岩黏土
(b) 钻孔揭露层滑带, 为灰黄色泥化夹层

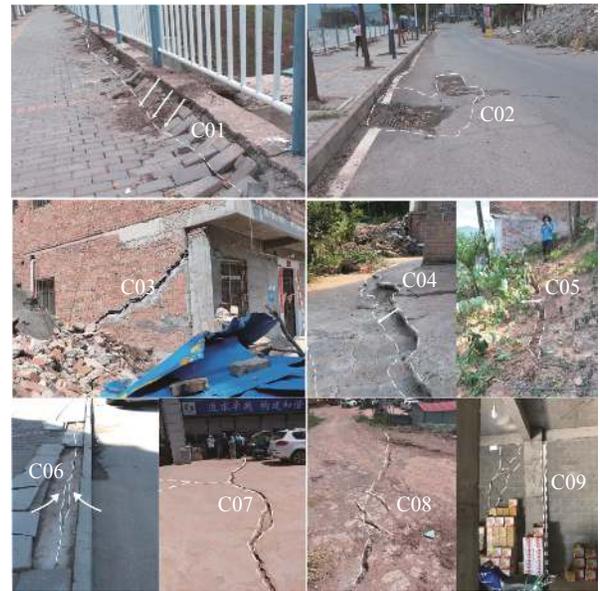
图 5 滑坡宏观变形破坏迹象
Fig. 5 Signs of macroscopic deformation and failure of landslide

地面裂缝主要包括前缘鼓张裂缝, 后部拉张裂缝和中部侧缘的剪切裂缝。前缘鼓张裂缝主要分布在坡脚金科路地面上, 隆起高度约 5 cm(图 5 中 C06)。拉张裂缝主要分布在滑坡后部, 局部宽度最大可达 20 ~ 50 cm(图 5 中 C04、C05)。剪切裂缝分布在滑坡中部左右两侧边界处(图 5 中 C07、C08), 长度可达 20 ~ 100 m, 裂缝宽度最大约 20 cm。

滑坡体中部位置西坪村的建筑物变形十分严重, 变形迹象包括墙体裂缝、立柱倾斜等(图 5 中 C03、C09)。滑坡中部的国道 G348 路面在滑坡北侧边界处出现显著地面拉裂, 拉裂缝宽 1 ~ 6 cm, 裂缝沿滑坡边界上、下贯通, 局部路面沉降 10 ~ 30 cm(图 5 中 C01、C02)。

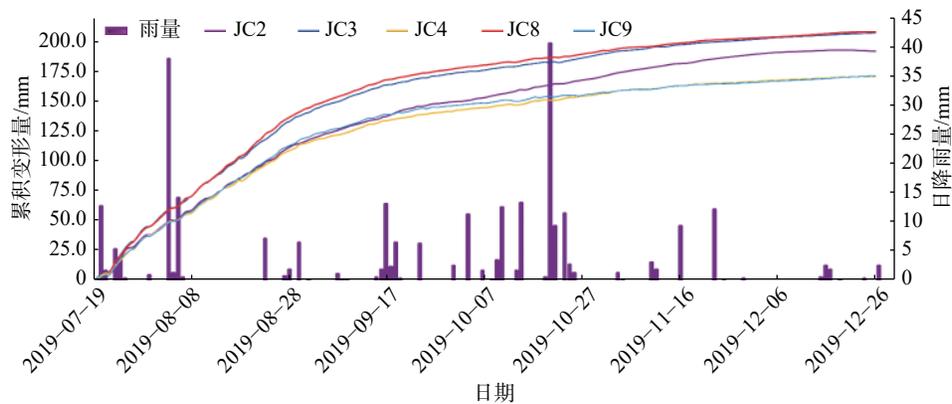
图6 滑坡中部地表位移监测曲线

位移量较小,边界附近监测点变形不明显(图1)。滑坡中部变形量大,7月到12月的累积位移最大达200 mm(图6),各监测点变形方向均为95°左右。可将滑坡位移方向分解为岩层倾向和坡向的矢量,矢量大小可大致反映层面、坡向对滑移的贡献大小。由图7可知,滑坡滑移趋势受层面和坡向的共同作用,岩层倾向与滑坡方

地表位移监测曲线显示(图6),2019年7月以来,滑坡位移持续增大,2019年8月28日前,滑坡呈匀速变形状态,日水平位移量2~5 mm/d。2019年8月18日,滑坡前部开始设置应急处置抗滑桩,9月23日,抗滑桩施工完毕,累计完成抗滑桩35根,桩长35 m,桩间距5 m。抗滑桩的不断成桩,使得2019年8月25日至2019年9月25日滑坡变形速率日渐减弱。2019年9月25日后,滑坡呈缓慢匀速变形状态。变形速率发生变化的时段处于应急抗滑桩开始发挥作用的时段。应急抗滑桩发挥作用后,滑坡变形速率减缓,直至发生缓慢匀速变形,变形速率0~0.5 mm/d。可见应急抗滑桩对控制滑坡变形发挥了作用,但滑坡仍处于缓慢匀速变形状态,滑坡尚未得到彻底根治。

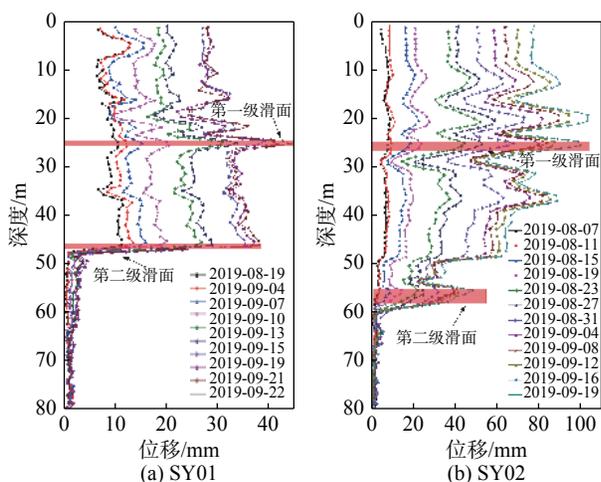
图 8 深部位移监测曲线

SY01位移曲线表现为底部小,向上位移逐渐增大,第一个滑动面位于25~26 m,第二个滑动面位于46~47 m之间。SY02深部位移监测曲线也揭露了两处明显的滑动面,第一个滑移面深度为25~26 m,第二个滑移面深度为55~57 m。深部位移监测结果与钻孔岩芯揭示的两层滑动面相符。

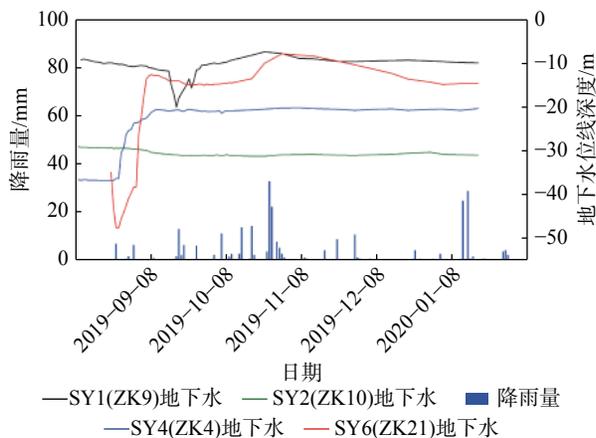
图 9 研究区降雨和地下水位曲线

降雨和地下水:研究区地下水赋存于碎裂状泥岩、砂岩地层中,地下水较丰富,地下水流量约57.70 m³/d。水位监测曲线(图9)显示,地下水位稳定,受降雨影响

不大。一方面, 饱水状态的泥化夹层或软弱岩体抗剪强度较低。另一方面, 地下水运移使斜坡岩土体遭受动水压力、扬压力作用, 下滑力增大, 抗滑力降低, 不利于斜坡稳定。该滑坡所处地形坡角不大, 地下水作用是导致滑坡变形的重要因素。

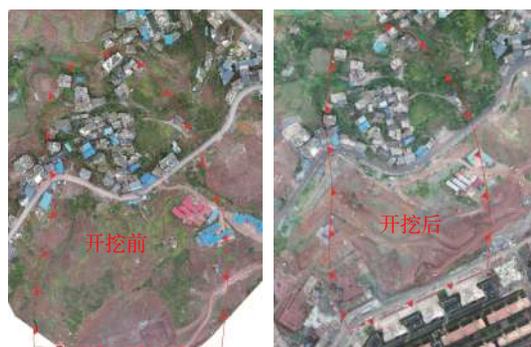
图 10 开挖前后白杨湾滑坡航拍图

人类工程活动: 近年来, 在研究区中部和后部的西坪村陆续修建了 40 多栋 3~6 层的房屋, 增大了滑坡的下滑力。最重要的是, 2019 年 4 月至 7 月, 由于滑坡前部金科城小区的扩建, 滑坡前缘开挖了体积约 $30 \times 10^4 \text{ m}^3$ 的岩土体, 形成多级阶梯式边坡(图 10), 开挖显著降低了滑坡的抗滑力, 直接导致滑坡变形失稳。

在前期已设应急处置抗滑桩的基础上, 采取“搬迁避让+工程治理+专业监测”的综合防治对策, 以达到彻底根治滑坡的目的。一方面, 对滑坡后部居民 136 户 588 人进行搬迁避让。另一方面, 结合金科城后期建设和城市规划发展需要, 采取“削方减载+排水工程+锚杆格构”进行综合治理, 削方减载后既要不影响金科城后期建设, 又要兼顾土地整治用于后期建设。削方体积约 $150 \times 10^4 \text{ m}^3$, 削方后设置排水系统, 对削方形成的边坡采用锚杆格构进行护坡。第三, 对滑坡进行持续专业

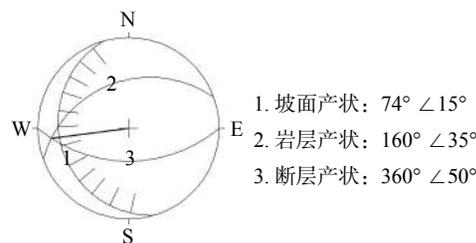
图 11 极射赤平投影图

岩层呈单斜构造, 右侧边界发育正断层, 断层面与岩层面相交切割形成楔形体, 交线倾向坡外(图 11), 倾角约 13° , 形成顺斜向滑移的空间组合边界。其中, 断层

面控制滑坡右侧边界, 岩层面控制滑带和左侧边界, 滑坡受层面、断层面控制, 随着滑坡坡脚大规模开挖, 显著降低了滑坡抗滑力, 直接诱发滑坡沿断层面与岩层面相交切割形成的楔形体顺斜向滑移破坏。
