冯志刚, 韦国建, 张汉猛, 等. 西南某水电站断裂构造和层间溶蚀带组合岩溶渗漏研究[J]. 中国岩溶, 2022, 41(5): 728-735.  
DOI: 10.11932/karst2021y33

# 西南某水电站断裂构造和层间溶蚀带 组合岩溶渗漏研究

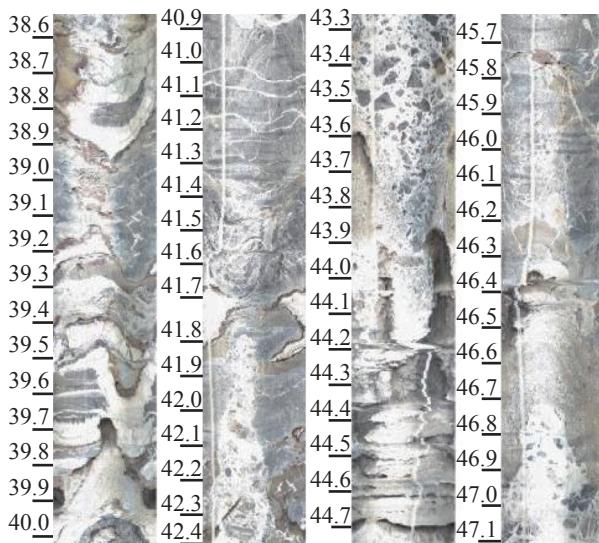
按其延伸趋势推测它们是相互连通的。右岸地下岩溶大致从清水河边沿小断层向下游山体延伸,近岸附近呈近水平管道状。为查明库水渗漏通道,在坝址区开展了大量的钻探及物探工作,揭露了大量的溶蚀裂隙和涌水点(图2,图3)。

图2 R1U55孔深部岩溶裂隙发育情况

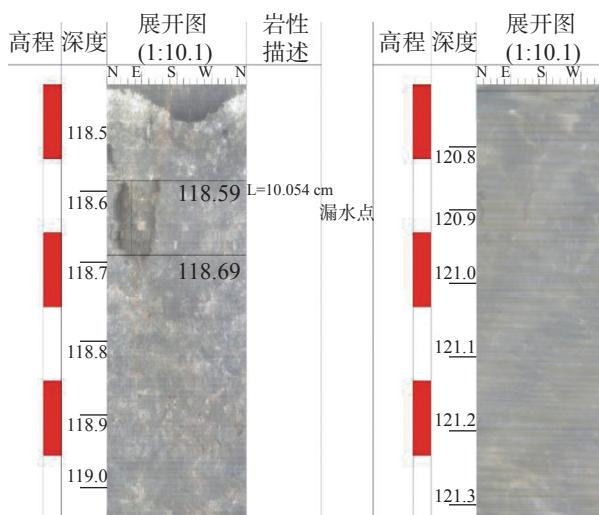
图3 RBQ-5孔内电视陡倾角裂隙涌水点

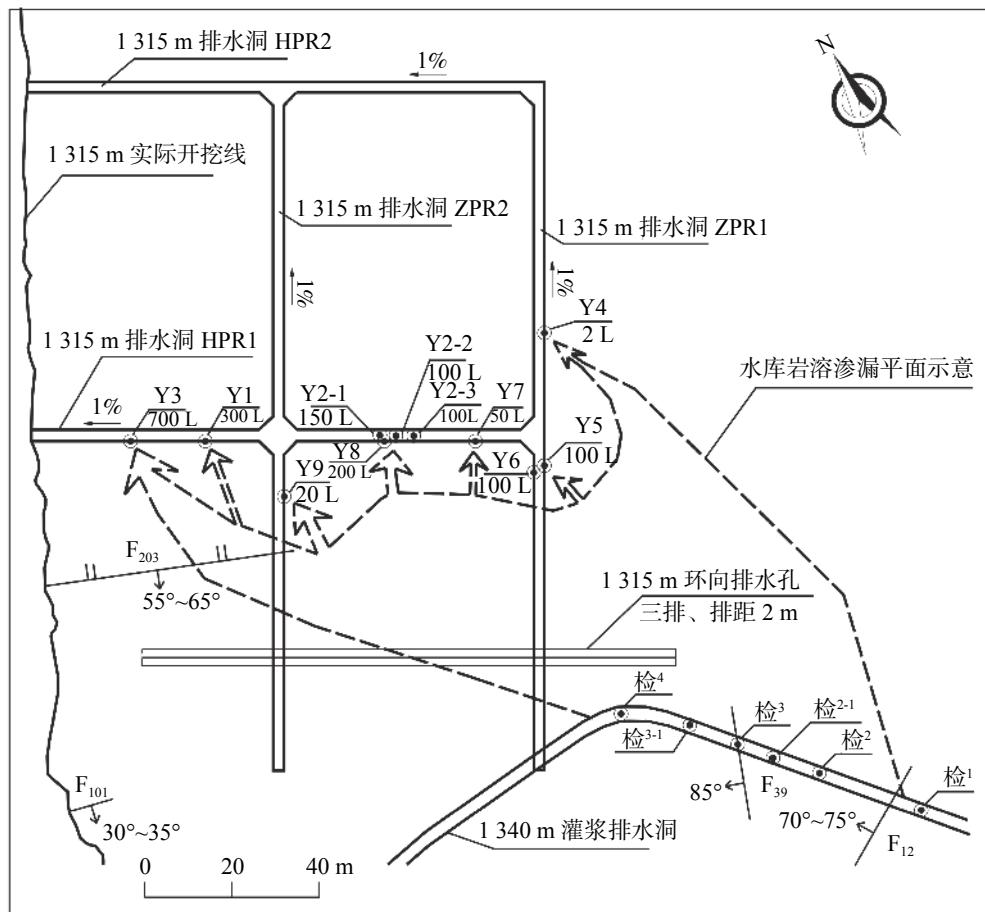
当库水位上升至1325 m时,坝区右岸抗力体1315 m排水洞HPR1(第一道横向排水洞)与ZPR2(第二道纵向排水洞)交叉口以右约22.0 m位置,底板部位的地质薄弱点Y2-1开始冒浑水,之后Y2-2、

Y2-3和Y1依次出水,一周后Y3开始涌水(图4)。

随着库区水位迅速升高,大量泥质充填物从各涌水点涌出,之后水质逐步变清,渗漏量逐步增大。在库水抬升至1357 m前后,对Y1和Y2设置反滤。后随库水位升高,依次出现Y4-Y9涌水点。库水位达到1357 m时,Y3涌水量大于700 L·s<sup>-1</sup>。库水位基本稳定在1366.5 m时,测得总渗流量约1.9 m<sup>3</sup>·s<sup>-1</sup>。

图 4 1 315 m 排水洞和 1 340 m 灌浆排水洞平面示意图

库水经断层破碎带  $F_{12}$  下渗, 至深部岩石层面溶蚀带后, 往下游以 30°倾角沿溶蚀带逐步抬升, 并在 1220~1260 m 高程、检 4 孔附近和断层  $F_{12}$  至检 2 孔一带绕过帷幕线。局部遇竖向溶槽、溶沟、溶洞等地质薄弱地带, 向上渗流, 最终从 1315 m 排水洞地质薄弱点涌出(图 4, 图 6)。

对在勘察和灌浆过程中发现的主要渗漏通道的区域进行了封堵灌浆。在 1340 m 灌浆排水洞检 4~检 3 及检 2~检 1 之间, 布置 3 排灌浆孔, 排距 1.6 m, 孔距 2 m(局部加密至 1 m), 孔深 130~140 m; 检 3~检 2 之间, 布置 2 排灌浆孔, 排距 1.6 m, 孔距 2 m, 孔深 130 m。

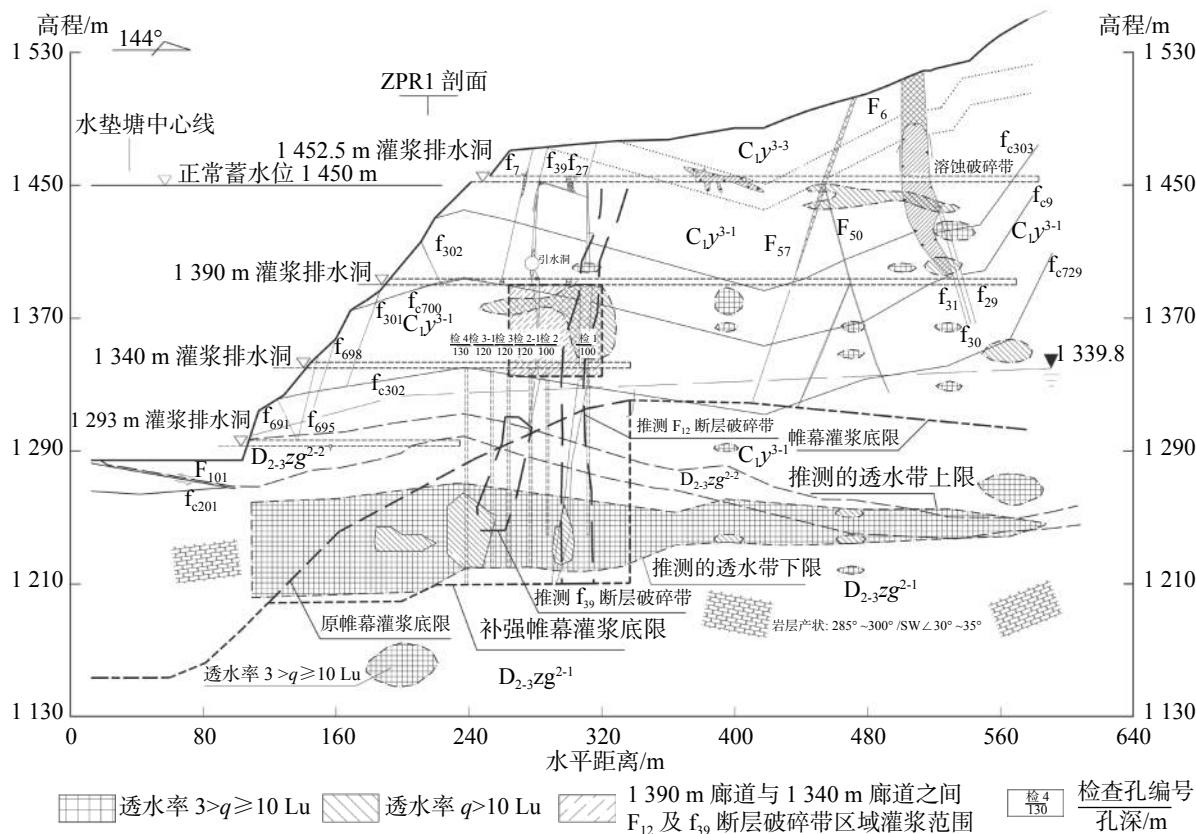
为了进一步查明坝区库水渗漏途径,在坝址右岸布置了15个钻孔,孔底高程在1133.3~1249.9 m之间。对坝基帷幕底高程以下进行了121段钻孔压水试验,统计结果见表1,坝轴线处右岸岩体透水性分布示意见图5。

试验结果表明,右岸坝基帷幕底高程以下,在1140~1250 m高程(孔深150~180 m)范围内未发现连续3段以上 $q \leq 1$  Lu的区域。坝基帷幕底高程以下 $q \geq 3$  Lu渗透区域呈带状分布,主要分布于1200~1260 m, q值为3~75 Lu,往右岸逐渐减小至2~8.82 Lu。

图 5 坝轴线处右岸岩体透水性分布示意图

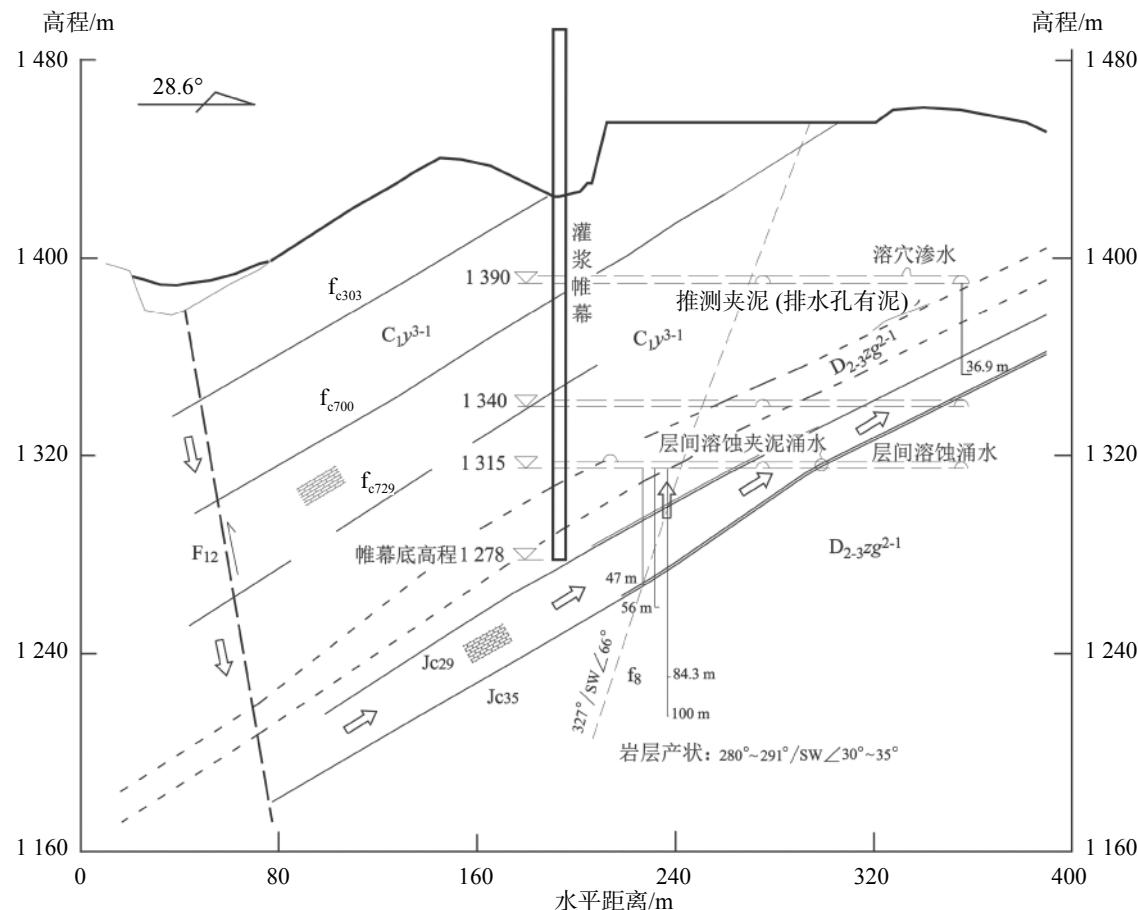
图6 ZPR1渗水通道剖面示意图
