三峡库区典型顺斜向岩质滑坡变形破坏特征及失稳机制分析

Deformation characteristics and failure mechanism of large-scale obliquely dip rock landslide in the Three Gorges Reservoir Region

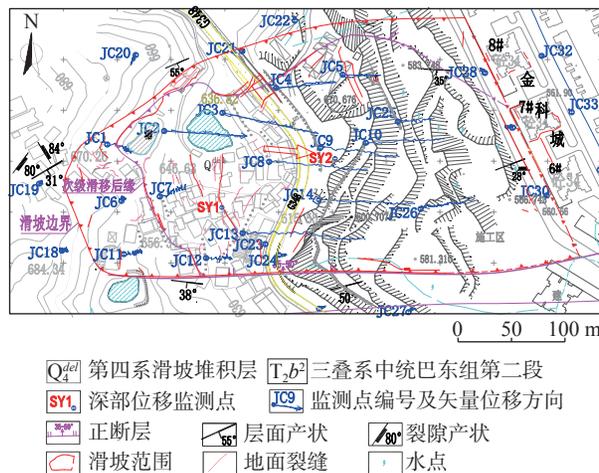
图 1 白杨湾滑坡平面及监测点分布图

白杨湾滑坡纵长 350 ~ 400 m,横宽 180 ~ 230 m,厚度 20.70 ~ 69.00 m,面积 $7.30 \times 10^4 \text{ m}^2$,体积约 $320 \times 10^4 \text{ m}^3$ (图 1)。根据监测矢量位移方向,滑坡主滑方向 95° 。滑坡右侧边界发育一条正断层,断层延伸长约 4 km,走向 $85^\circ \sim 90^\circ$,倾向北—北西向,倾角 $35^\circ \sim 50^\circ$,断层带宽 8 ~ 12 m。研究区地势西高东低,高程 530 ~ 630 m,坡角平均约 28° 。滑坡区后缘主要为耕地,地势平坦;中部西坪村分布着大量住宅建筑和国道 G348;滑坡坡脚为多级人工开挖边坡,前缘延伸至金科城小区。研究区附近分布 3 条冲沟,分别为滑坡北侧边界,西北侧以及南侧边界,三条冲沟近年来均已回填。

位移量较小,边界附近监测点变形不明显(图1)。滑坡中部变形量大,7月到12月的累积位移最大达200 mm(图6),各监测点变形方向均为95°左右。可将滑坡位移方向分解为岩层倾向和坡向的矢量,矢量大小可大致反映层面、坡向对滑移的贡献大小。由图7可知,滑坡滑移趋势受层面和坡向的共同作用,岩层倾向与滑坡方
